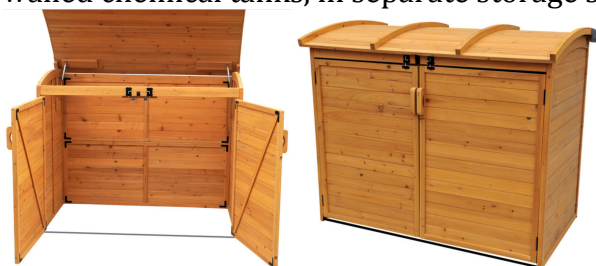
Unfortunately, storing enough chlorine and acid on site for the chemical feeders, requires significantly more space than the old tablet erosion feeder. There is also important hazardous material protocol that must be followed to safely store these chemicals, and provide adequate protection against unintended chemical spills and/or mixing of chemicals. A concrete pad and fence enclosure at both North and South Pools was recently built. 5-foot tall Texas Privets were planted adjacent the new chemical storage enclosure. Chlorine and acid will be stored in double walled chemical tanks, in separate storage sheds (pictured below).

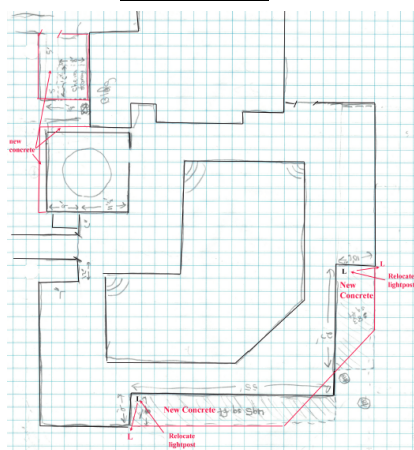
North Pool

The demographics of Altamira One are evolving. The original ‘over 55’ community with an average of 1-2 adults living in each home, has now evolved into a significant number of family households with 1-2 adults and 1-3 children. The dynamics of pool use on a busy summer day have consequently changed. The pool deck has become much more crowded during periods of peak use. Consequently, over a period of several years, the Board has discussed in open Board meetings and ultimately approved, a modest expansion of the pool deck that would occur concurrent with the new pool fence enclosure project that is described later. (See photos below for detail)

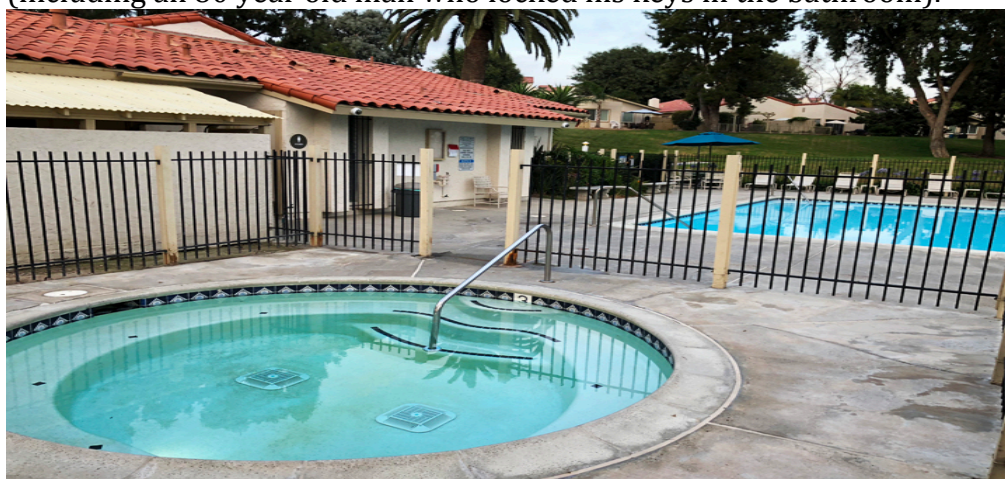
The photo below shows the existing pool fence enclosure at our North Pool. This enclosure has not been an effective deterrent for unauthorized access into the pool and spa area. Eye witnesses and security video has shown people of all ages jumping the fence to get in or out as desired (including an 80 year old man who locked his keys in the bathroom).

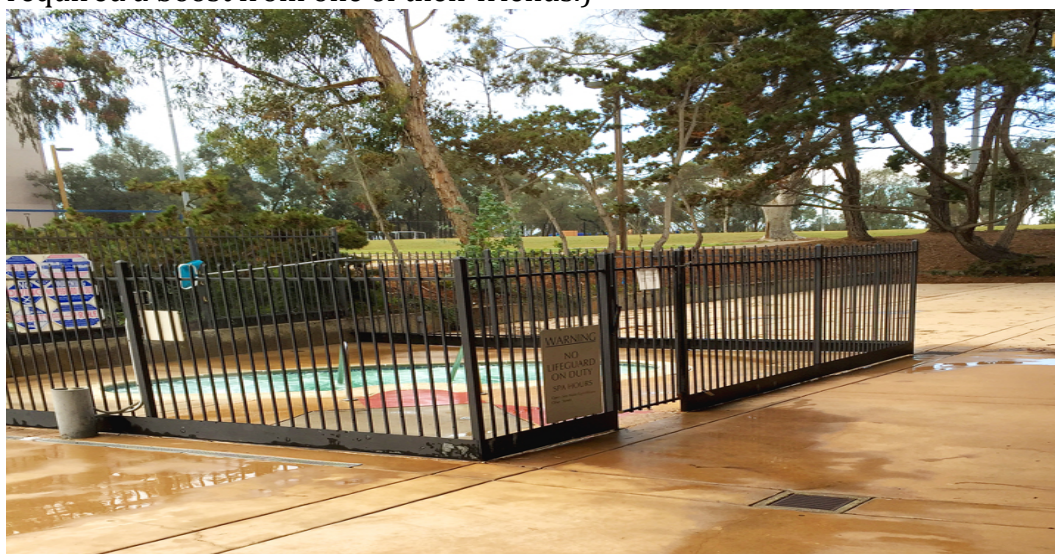
In an effort to prevent after hours use of a hot tub located on the UCSD campus, the spa enclosure pictured below was retrofit with a 6-foot tall iron rod fence with spikes on top. This design proved to be an ineffective deterrent against after hour access. Teens simply placed a towel over the top of the fence to cover the sharp spikes, then hopped over the fence. (The shorter teens just required a boost from one of their friends.)

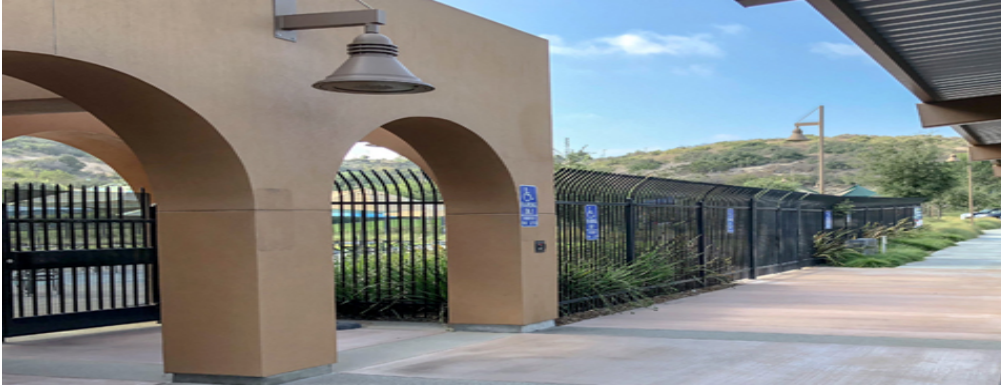
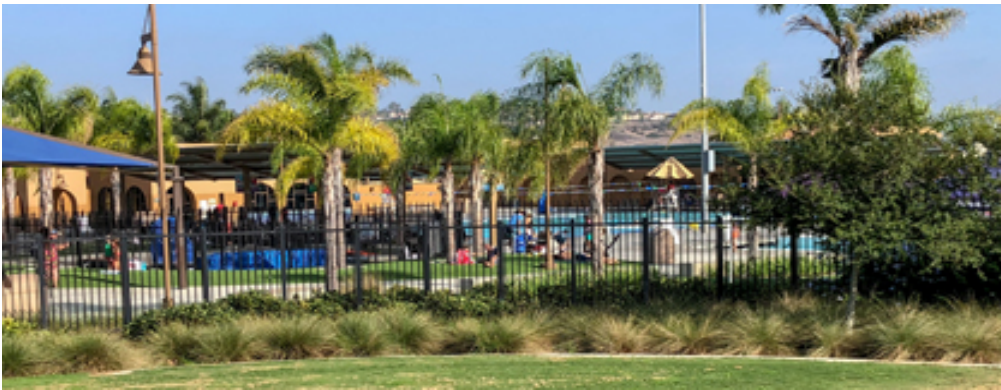
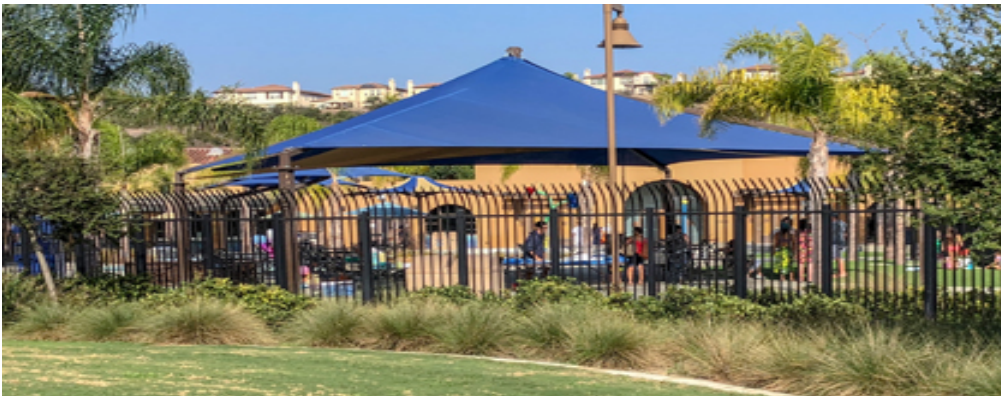
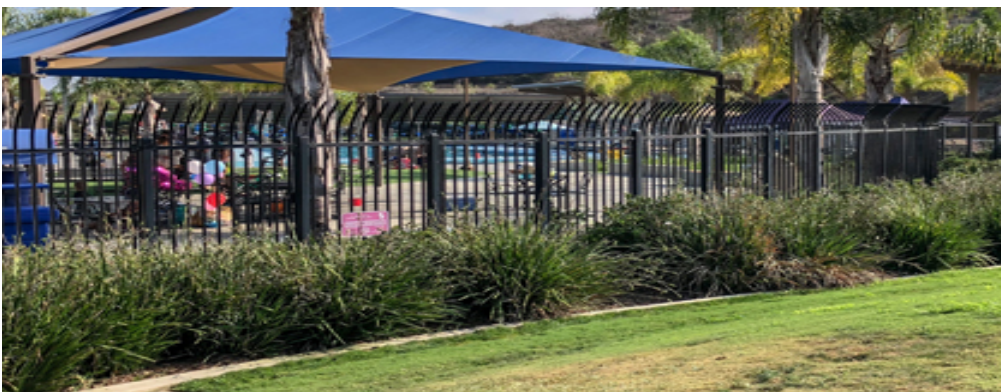
The City of Carlsbad recently built the beautiful Alga Norte Aquatic Center. Risk management was an important part of the design of their new facility. Below are several photos that show a fence design that has proven to be an effective deterrent against unauthorized access. This 7 foot tall iron rod fence includes a design that curves the spiked bars outward at the top, making it very difficult (if not impossible) for most people to climb over. This design was approved for Altamira One. Below are a few photos.
